# ***ROOF MANAGEMENT: THE LOW HANGING FRUIT FOR SOME FACILITY MANAGERS***

***...INFRARED2K, a new generation  
of X-ray like vision helps extend  
roof life, conserve energy and  
improve indoor  
air quality***

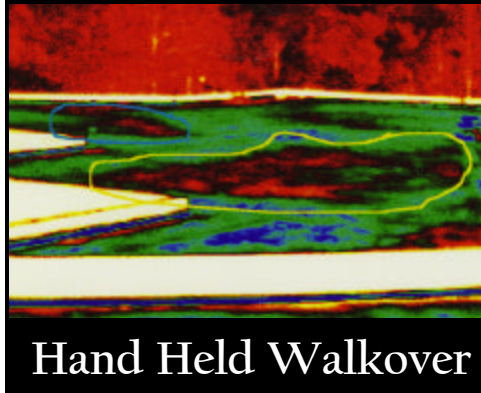
*Walk-over infrared inspections became available over a decade ago. The image above represents one of 100's of photos which must be captured at less than a 60 degree angle to provide full roof documentation. This documentation is subjective and often misinterpreted.*

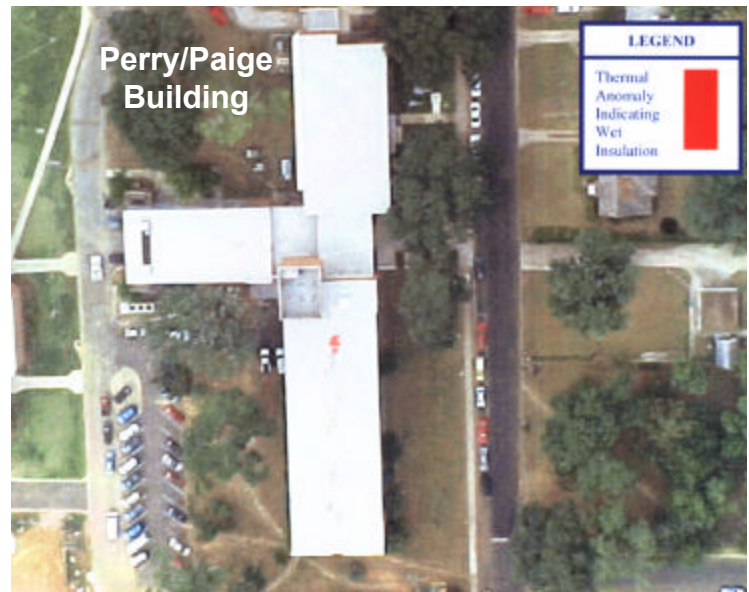
*Inspection of a new roof exposes a small problem which can be corrected at minimal expense by the installing contractor.*
